ROBERT FROST AUDITORIUM FORENSICS REPORT

HODGETTS+FUNG
MARCH 19, 2013

FOREWORD

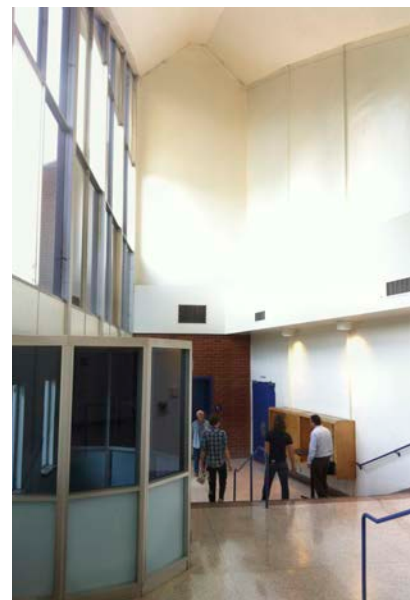
09

1. Lighting is poor and only provided by lights on the underside of a mechanical soffit built into the partition wall.
2. The ticket booths have no lid which makes it difficult for the sellers to hear patrons on the exterior if there is much activity in the lobby proper.
3. The trophy cases are pretty much defunct.
4. There is no real lobby-ness about the space and they act more as hallways.
5. There is no buffer between the lobbies and the house which surely causes many light and noise intrusions during performances.
6. The general appearance of what could be a grand space is humdrum and dated.

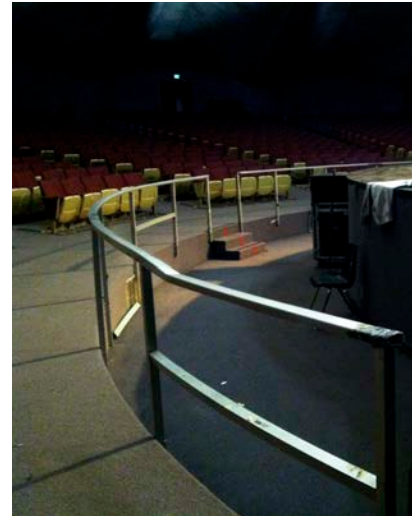
10

6. The low rake of the seating and a lack of staggering is cause for many terrible sightlines.
7. The K-13 flocking has collected a lot of dust and has a negative appearance.

14. House lighting is unfavorable and inadequate.
15. Orchestra pit sometimes floods.
16. There are a number of things stored out in the open in the rear cross aisle at the back of the house.

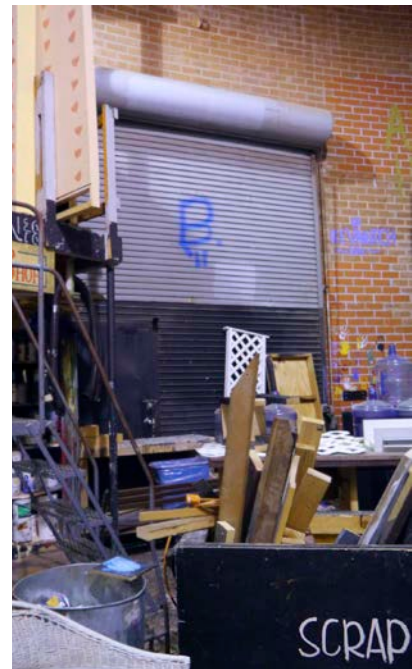
19

1. The painting pit is covered by storage and unused, signaling a failing to recognize and utilize it for the purpose for which it was built.
2. The painting pit is full of what appears to be old scrap cutoffs and other trash.

3. When last viewed the pit had a small amount of standing water on the bottom. There is quite a bit of rusted metal including the metal beam that holds the pit access door in place.

11. In windy conditions the roll-up doors on both sides of the shop can vibrate, creating noise which can be heard on stage.
12. There did not appear to be any provision for dust extraction or removal of vapors from the paints, solvents, and glue used in the construction of sets and props.

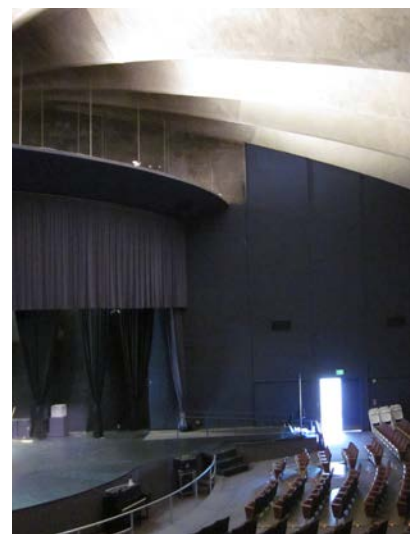
24

1. Lack of circulation between lobbies is a cause of confusion causing theater patrons to step outside and circle the back-of-house structure in order to access the adjacent lobby.
2. Stairway access to the restrooms and their position at extreme ends of the lobby creates a potential conflict with current ADA requirements.
3. There are no light or acoustic locks on the entry doors to the auditorium resulting in distracting pulses of light and sound during performances.
4. The lack of wayfinding graphics identifying the tiers or sections of the auditorium beyond causes confusion.

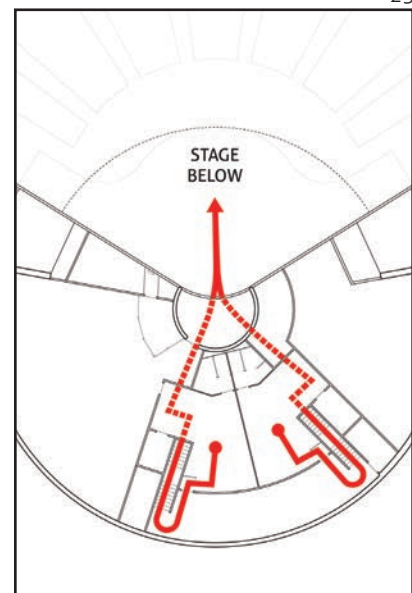
Plan - Stage Route

1. The radial location of the hallways creates awkward interior rooms with compromised functionality.
2. As there is no provision for circumferential circulation on the ground floor, actors and technicians wishing to cross from Stage Left to Stage Right must first go up one of the stairs, then cross the intervening dressing room before descending to the other side.
3. The hallways do not provide immediate access to the stage area.
4. The hallways and terminal doorways are not wide enough to accommodate a grand piano which requires accessing the stage only through the shop area which in turn compromises the utility of the shop.
5. Security requirements are complicated by the layout of the doors and keying systems causing confusion and delays.
6. "V" configuration results in both hallways converging at the same inaccessible point.

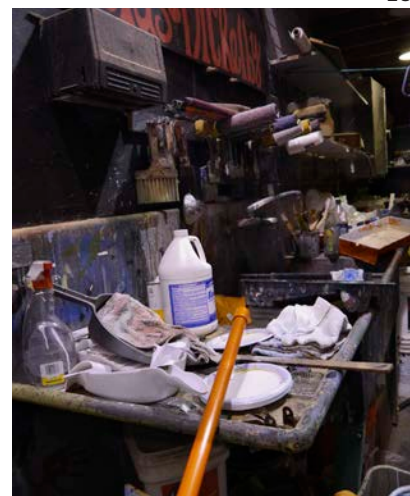
29

1. Even the dedicated storage spaces are underutilized, many lacking any kind of shelving or appropriate cabinetry.
2. The shop has no enclosed cabinetry or drawers for storage of tools or any other kind of necessary equipment and hardware for building sets.
3. The flat storage lofts in the shop are ad hoc and under built.
4. It is difficult to make out what is being stored in the stage

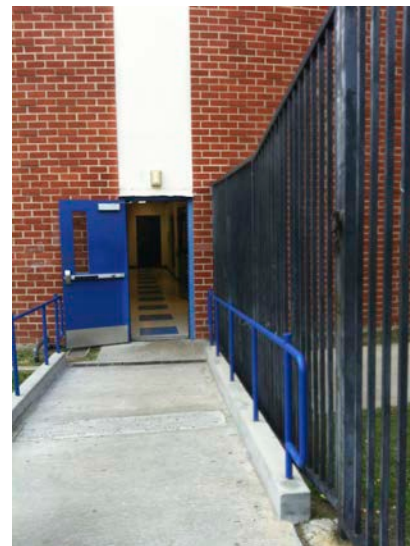
30

1. Faculty and administration express concerns about maintaining a watchful eye over so many doors that need to be kept secure.
2. There are concerns about the inability to curtail unwarranted student activity in the facility.
3. Having one door immediately outside the classroom that opens to the public side keeps the class from accessing fresh air from that door.
4. The location of the security fencing is not optimal and detracts from the building appearance and performance.
5. Entry to the Black Box is on the campus side of the security line.
6. For assemblies, the exits at the back of the auditorium cannot be used without unlocking the security fences as well. Meaning that students leaving out the back are effectively leaving the secure campus and then returning through a security fence.

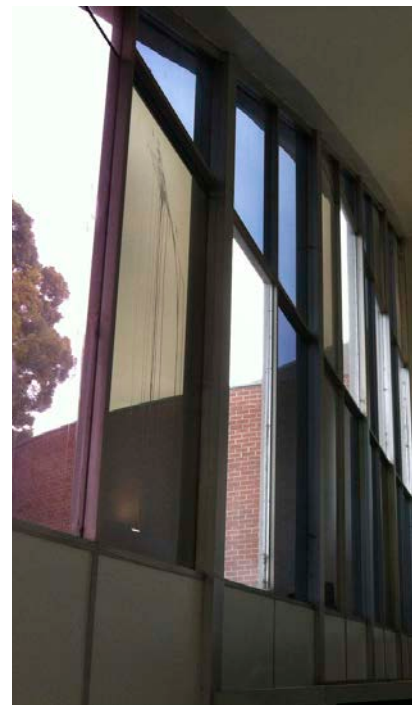
38

1. This system is architecturally in a state of disrepair.
2. Many of the inset glass panels have been broken and replaced over the lifespan of the building.
3. Several of the remaining panels are bowed and/or warped and show signs of failing in the future.
4. The bowed and warped glass panels may be an indication that the shell structure has deflected vertically over time and is now loading the curtainwall system. Based on the original construction documents, a joint was initially provided to prevent this from occurring. This joint may no longer exist.
5. Further investigation of the curtainwall system should be performed to determine the cause of the distress in this system.

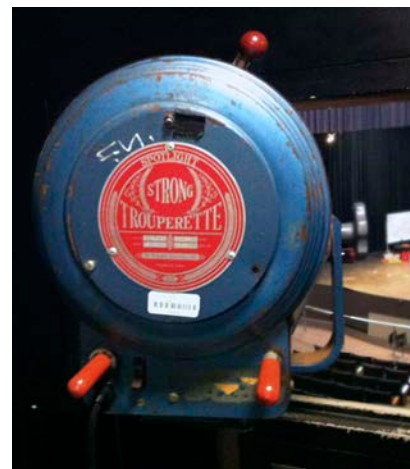
50

1. The dimmers are outdated, and require replacement. It is possible to replace part of the dimmer electronics, but this would void any warranty for the new parts, as they can't be warrantied with existing components.
2. The circuit distribution is dated, and requires replacement, and different locations.
3. The console is not as old as the rest of the system.
4. The lighting positions offered do not allow for even basic theatrical lighting to be done properly.
5. The front of house positions are far too low, and flat, for flattering lighting. These would be best described as balcony front lighting.
6. The overhead/overstage positions are not optimally located and configured correctly for the stage width and depth.
7. A basic front lighting position from a high angle does not exist in the room.
8. Data distribution is virtually non-existent, and not located at appropriate locations.

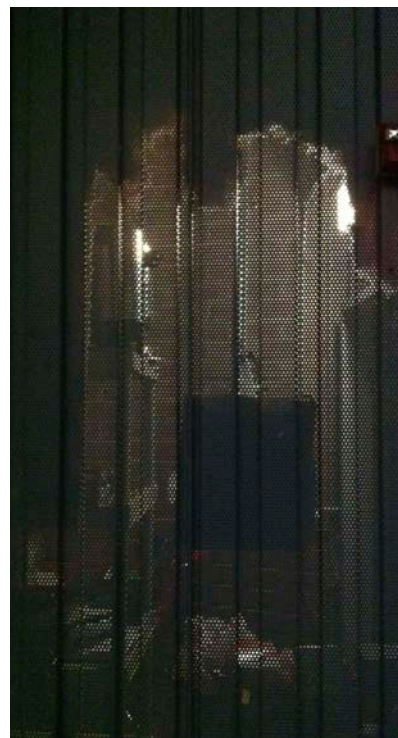
56

11. All access doorways to the house are not gasketed and lead in most instances directly into highly reverberant lobbies.
12. The key to the current low noise levels when air is running seems to be in large, slow RPM fans and low velocity air distribution from multiple points throughout the room.

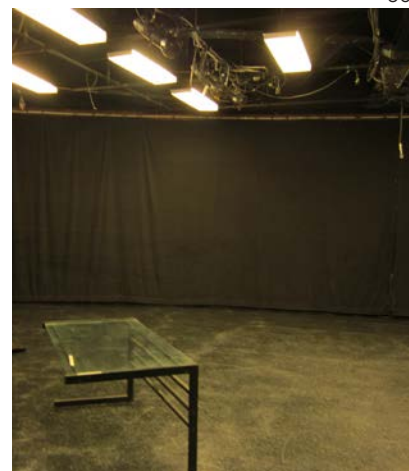
61

This is the most immediately-obvious acoustical deficiency of the room in its present condition. Airflow velocities, probably in several areas of the room, exceed good design practice. Of note is the noise and associated air pressure imbalance between a return air shaft to below, that serves the auditorium, and accessible via a door off a side (original) music practice room along the northwest wall. Although HVAC noise here was not measured, we estimate it to be approximately in the range of Noise Criterion (NC) 38-44 – possibly higher in some areas of the room. If this were even made half as loud as this estimate, it would still be nearly twice as loud as good design practice for a Black Box theater.

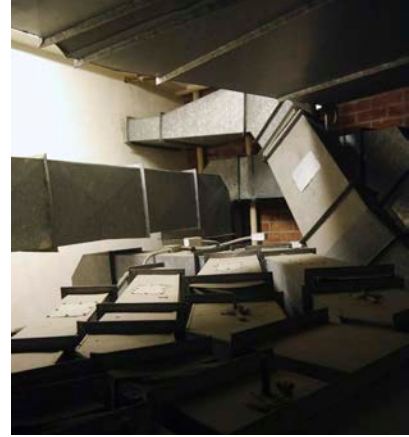
64

1. Other than the Black Box it seems most air delivery and return noise is sufficiently quiet now, we expect this is due to low velocities in ductwork.
2. Exterior insulation of ducts was observed in the catwalk realm, but that exhibits substantial deterioration since construction c. 1964.
3. The principal fans are on hard neoprene vibration isolators (we saw no seismic restraint) instead of the usual springs and neoprene.
4. We have seen no evidence of either duct silencers or sections of internally lined duct anywhere in the project.

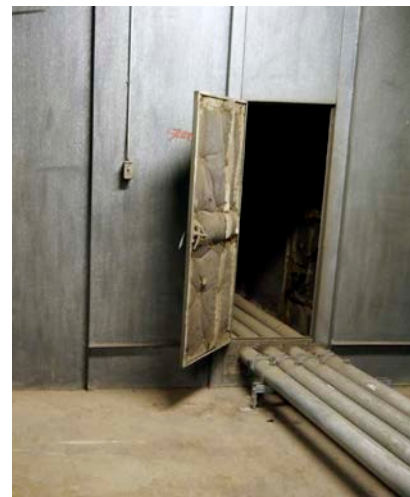
65

1. The equipment appears original from the time of construction and is well beyond its service life, therefore should be replaced with higher efficient systems. Table 1 (3.0) describes the zones and the main ducts serving these.
2. This equipment appears to be original and is well beyond its expected service life of 25 years.
3. Outside air ventilation rates need to be increased to meet present day indoor air quality with demand controlled (carbon dioxide sensing) systems installed to conserve energy during low occupancy periods.
4. Presently there is no air conditioning and increasing outside air rates and heat from new electronics will necessitate adding cooling for comfort.
5. The existing systems are constant volume whereas new systems can use variable speed fan motors which save energy costs.

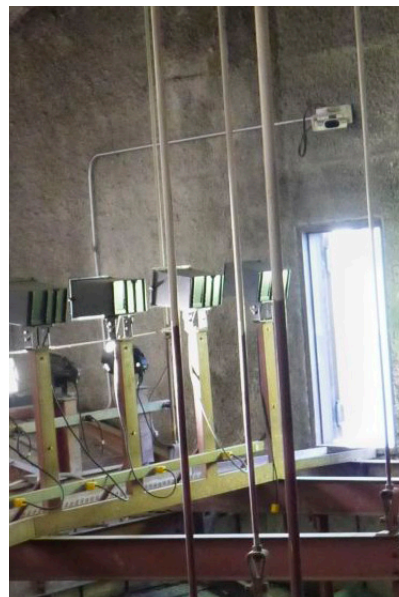
71

13. Damaged and non-functional exit signs and emergency lighting in the building did not appear to be installed.
