ROBERT FROST AUDITORIUM FORENSICS REPORT

HODGETTS+FUNG
MARCH 19, 2013

FOREWORD

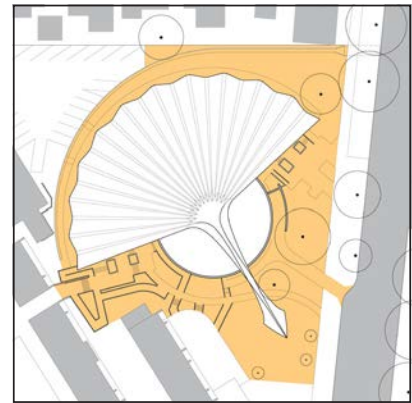
Site Plan

1. Re-engineering the courtyards for ADA compliance has caused a multitude of ramps to be cut into the site in such a way that makes this common space not optimal for any use or user.
2. The planters are degraded and seemingly not used for plantings.
3. The entry just on the campus side of the security fence is heavily used by students to access the Frost in general but also to enter the classroom in the backstage area.
4. Because the lowest terrace is below street level and worsened by the addition of a ramp, water has been an issue on the public entry side. Attempts to remedy have been made by an additional storm drain.

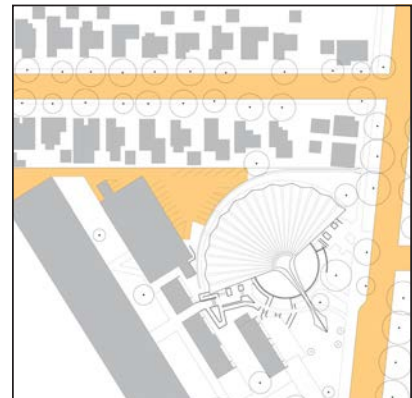
Site Plan - Parking Locations

1. Any public rental of the venue may cause friction with the neighbors, as street parking would become more of an issue.
2. Access to the shop loading dock is accessed by driving across a busy sidewalk in front of the High School.
3. The wall screening the shop door makes it difficult for a truck of any size to back in to the loading area due to a tight radius turn.
4. Access to the plenitude of parking on campus is difficult as the entrance is around the corner, not easy to find, and mostly not adjacent to the facility.
5. Often, there is a car parked in the shop loading area blocking both the loading door and the dumpster.

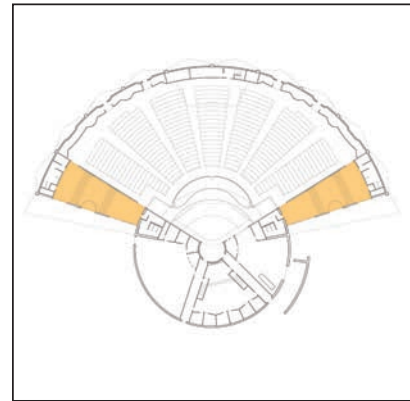
1st Floor Plan - Lobbies

1. Lighting is poor and only provided by lights on the underside of a mechanical soffit built into the partition wall.
2. The ticket booths have no lid which makes it difficult for the sellers to hear patrons on the exterior if there is much activity in the lobby proper.
3. The trophy cases are pretty much defunct.
4. There is no real lobby-ness about the space and they act more as hallways.
5. There is no buffer between the lobbies and the house which surely causes many light and noise intrusions during performances.
6. The general appearance of what could be a grand space is humdrum and dated.

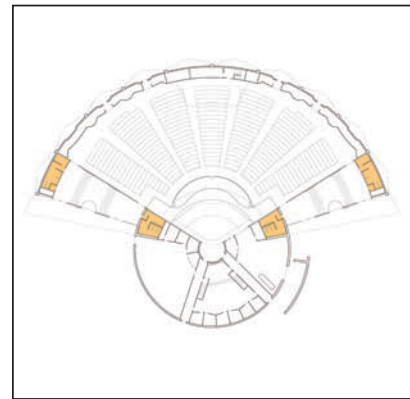
1st Floor Plan - Restrooms

1. All restrooms appear to be somewhat recently remodeled.
2. For the auditorium capacity both the ladies and mens restrooms have fewer fixtures than needed.
3. There are complaints about visual and aural disturbances with the proximity of the restrooms to the house entry doors.

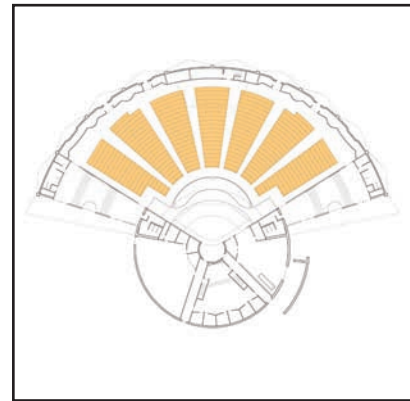
1st Floor Plan - Seating

2. The low angle of rise, probably due to wheelchair concerns, is less than ideal from a sight-line point of view.
3. Many of the seats in the back rows have been removed to salvage and replace other broken seats throughout the house.

5. Because the aisles radiate from center stage, becoming extremely wide at the back of the house, seating capacity is lost. This also leaves performers looking off stage with the sensation of a sparsely populated house.

6. The facility is also used, and desired to be used for smaller audiences of 350-500 but the seating layout is not conducive to this.

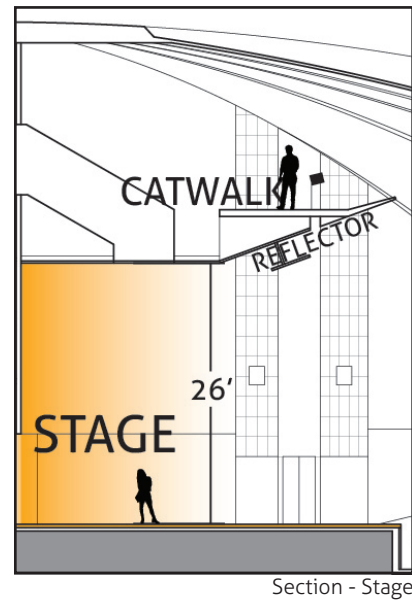
Section - Stage

1. The original design gave the reflector a chance of working but has since been modified and the new front curtain obscures sound instead.
2. Only approximately half the lights used to illuminate the shell are used and less than that work.
3. Limited access to the top of the canopy creates difficulties with upkeep of the lights.
4. The radial lighting grid makes it difficult for lighting designers to learn the trade and design even simple lighting schemes.

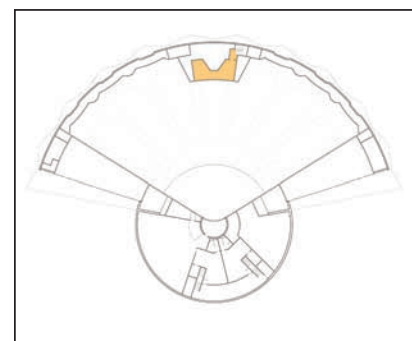
2nd Floor Plan - Control Room

1. Almost everything in this room seems cobbled together.
2. There is an overall sense of disrepair with holes in walls,

- 3. paint peeling, bare wires, exposed circuitry, etc.
- 3. There is an absolute lack of any kind of storage or shelving. Lighting fixtures, and other technical theatre objects are on the floor or stashed and piled in corners.
- 4. Temporary folding tables are being used for mixing boards, table lamps, backpacks, books, lunch sacks, a computer monitor, etc.

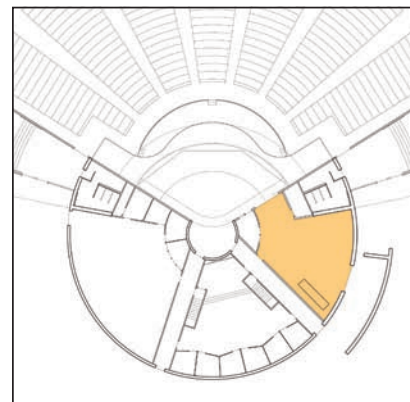
1st Floor Plan - Shop

1. The painting pit is covered by storage and unused, signaling a failing to recognize and utilize it for the purpose for which it was built.
2. The painting pit is full of what appears to be old scrap cutoffs and other trash.

3. When last viewed the pit had a small amount of standing water on the bottom. There is quite a bit of rusted metal including the metal beam that holds the pit access door in place.

10. The mercury vapor lamps are the sole source of lighting, and as they take up to five minutes to become active, the absence of immediate lighting creates a situation in which maintenance and more spontaneous access is discouraged.

11. In windy conditions the roll-up doors on both sides of the shop can vibrate, creating noise which can be heard on stage.
12. There did not appear to be any provision for dust extraction or removal of vapors from the paints, solvents, and glue used in the construction of sets and props.

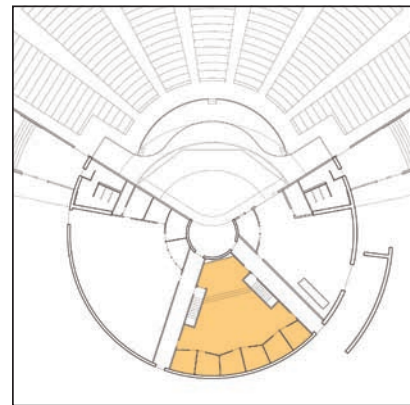
1st Floor Plan - Classroom

1. Noise and vibrations are very evident in this space, since much of the ductwork from the air handling units descends from the 2nd floor through the ceiling immediately outside the entry door.
2. The placement of the platform at the apex of the space creates a useful presentation space for lectures.
3. The location of the offices is convenient for instructors.
4. If rehearsal or a production is going on there is quite a bit of noise transference from the hallways and upstairs dressing rooms into this space.
5. There are no windows, and very little capacity to bring fresh air into the space since only one of the doors is on the campus side and can be left propped open.
6. Apparently this space can get unbearably hot.

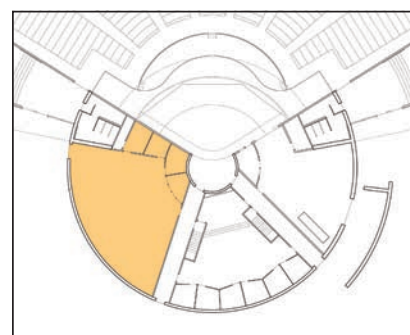
1st Floor Plan - Black Box

1. There is little or no backstage space, making it difficult to stage entrances from stage right to stage left.
2. The single door opening to the exterior has no light lock.
3. Entrance doors are conventional in size, limiting the size of sets and props that can be utilized.
4. Retrofit light pipe is close to ceiling which limits the positioning of stage lighting.
5. There is no access to the shop.
6. The immediacy and size of the air return shaft off the storage closet brings quite a bit of HVAC noise intrusion into the space when it is on.
7. There's no closed, sound proof booth from which to operate controls and manage the production.
8. The risers for the audience appear to be adequate, but probably do not conform to ADA requirements.

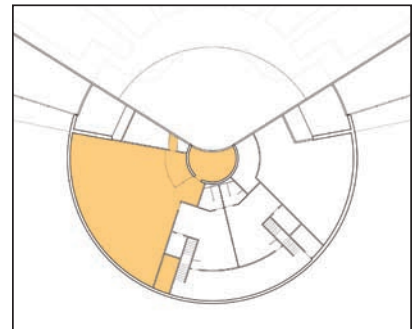
2nd Floor Plan - Mechanical Rm

1. Most of the ductwork looks original, although a few sections appear to have been replaced.
2. There is a gracious amount of open floor space.
3. What appears to be major electrical service is run through pipes along the floor of this space and into the circular interior room.

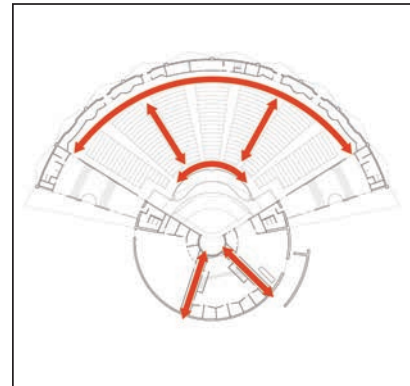
1st Floor Plan - Circulation

1. Lack of circulation between lobbies is a cause of confusion causing theater patrons to step outside and circle the back-of-house structure in order to access the adjacent lobby.
2. Stairway access to the restrooms and their position at extreme ends of the lobby creates a potential conflict with current ADA requirements.
3. There are no light or acoustic locks on the entry doors to the auditorium resulting in distracting pulses of light and sound during performances.
4. The lack of wayfinding graphics identifying the tiers or sections of the auditorium beyond causes confusion.

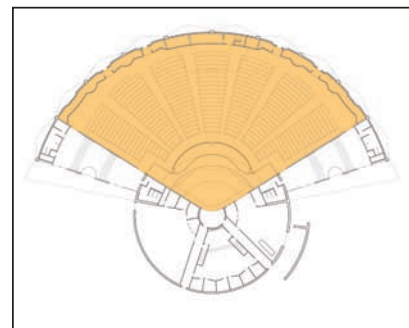
1st Floor Plan - House

7. There is no lift/ pit access for wheelchairs or large/ heavy instruments.
8. The flat floor risers at the seating sections, combined with sloped aisles, create a tripping hazard into the rows.

9. The 15'-0" gulf created by the orchestra pit and front cross

aisle disassociates the stage from the audience. Also, while it is sort of a hybrid endstage/ thrust stage, the benchmarks of thrust stage venues from that vintage – the Olivier, Vivian Beaumont, Mark Taper, Guthrie, Stratford Festival - had significantly fewer seats and/ or a balcony level, a lower stage height, a significantly steeper seating rake, and no orchestra pit. The pie-shaped configuration also places the majority of seats further from the stage.

10. There is a perception that the stage floor is too high – see above.
11. There is a perception that the far side sections feel particularly remote from the stage. In addition to the angle and distance, another contributor is the geometry. These two far sections are the only ones not radiating from the center point of the stage, instead bridging the geometries of the room and

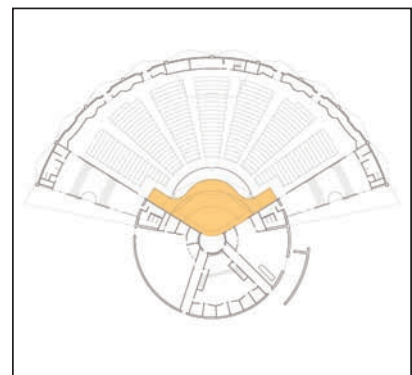
1st Floor Plan - Stage

1. The stage area cannot shrink in size. There is the potential for infill platforms over the pit to extend the stage closer to the seating.
2. The visual extension of the stage created by the flanking side

7. We understand that the stage floor is causing dancer injuries due to its surface condition. It will need to be inspected and either repaired or replaced as required. The existing architectural drawings show 25/32" hardwood strip flooring on 1" subflooring over 2x sleepers at 16" o.c. The lack of resilient pads to create a semi-sprung floor is less than ideal for dance.

9. The orchestra pit section in front of the stage results in a large gap at the front of the stage.

8. A dance surface that can be rolled out for rehearsal and performance, such as Harlequin Cascade, would alleviate some of the concerns with the condition of the top surface on a high school multi-purpose stage. Storage of the dance surface is a consideration.

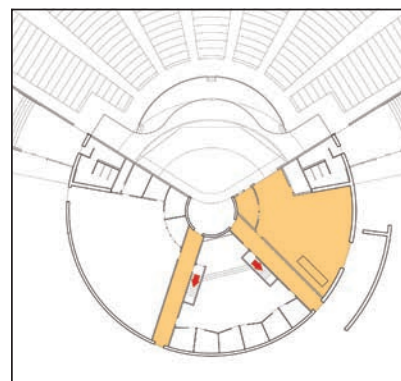
1st Floor Plan - Shop & Hallways

5. The makeup room amenities are dated, and fluorescent makeup lighting is undesirable.
6. The doors to the restrooms do not close.
7. We understand that for large shows the dressing area is undersized, which we believe is due to a perfect storm of room shape, circulation, lack of sufficient toilet facilities, lack of a green room for holding, and the lack of wardrobe support, which has caused the takeover of one of the dressing rooms.

8. There is insufficient and/or lack of front of house and back-stage storage for loose seats, concessions, lighting instruments, sound equipment, sets, wardrobe, props, dance floor, choral risers, piano and instruments.

9. Set storage is currently on a loft inside the shop, with a broken floor, and accessed via ship's ladder, making it difficult to

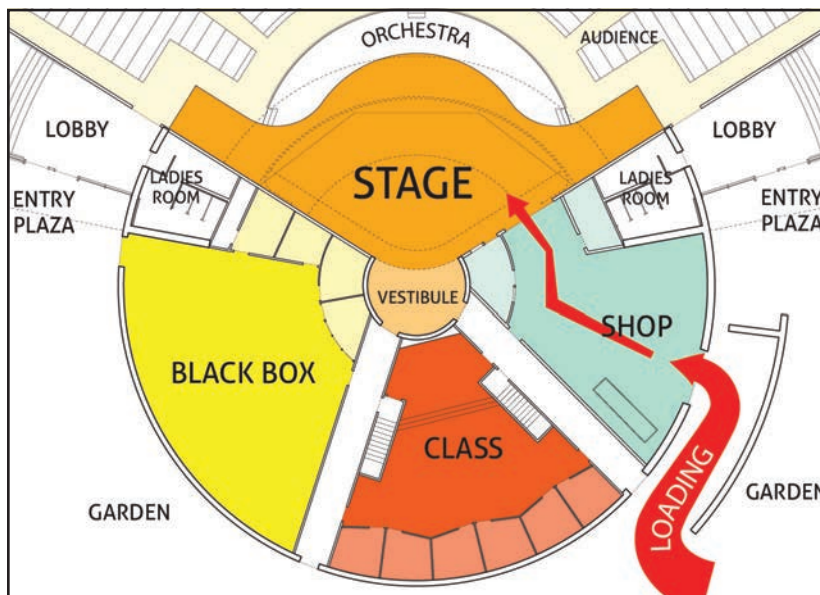
1st Floor Plan - Loading Dock to Stage Route

1. Load-in requires a 90-degree turn into the building. An overhead door at the far end of the load-in court leads into the shop, but the clear path of travel required through the shop would greatly affect the use of that room. Subsequently, most load-ins occur through the 3'-2" door that leads into the 6'-0" wide corridor, ending in the 19'-0" round upstage zone. There is no sound and light lock leading to the stage from this corridor.
2. The stairs are really too narrow to efficiently accommodate passage of two people in costume in opposite directions.

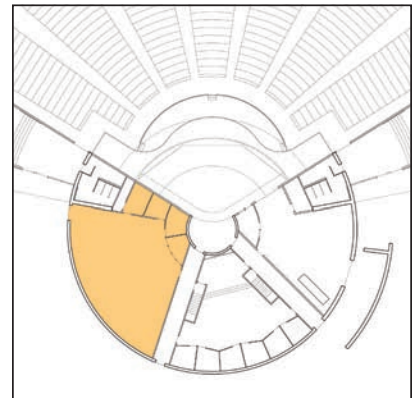
1st Floor Plan - Black Box

- 1. There is no connection to the shop or backstage load-in other than through the classroom. Direct load-in can occur through an outside door, but that doubles as the public entrance.
- 2. There are no sound and light locks from either the outside or backstage corridor doors.
- 3. The width, curved shape, and available ceiling height are less than ideal.
- 4. Other than a few small rooms serving as an office and control room, all production support spaces including dressing rooms are shared with the auditorium.

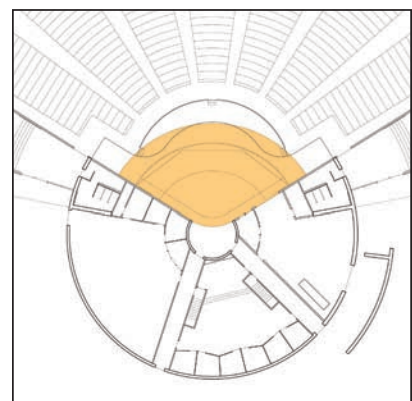
1st Floor Plan - Overhead Canopy

- 1. The overhead rigging is dangerous to use as currently configured, as it requires a lift or ladder.
- 2. The pipes are not always in the correct position, as the stage curves.
- 3. New curtains and tracks are being currently explored for the upstage area, which would solve the upstage area masking.
- 4. Flexibility is minimized due to the configuration

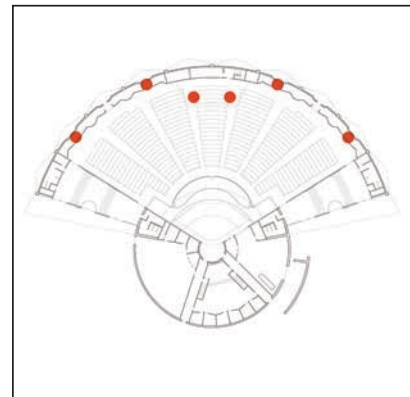
Plan - Overhead Front Lighting Positions

1. The dimmers are outdated, and require replacement. It is possible to replace part of the dimmer electronics, but this would void any warranty for the new parts, as they can't be warrantied with existing components.
2. The circuit distribution is dated, and requires replacement, and different locations.
3. The console is not as old as the rest of the system.
4. The lighting positions offered do not allow for even basic theatrical lighting to be done properly.
5. The front of house positions are far too low, and flat, for flattering lighting. These would be best described as balcony front lighting.
6. The overhead/overstage positions are not optimally located and configured correctly for the stage width and depth.
7. A basic front lighting position from a high angle does not exist in the room.
8. Data distribution is virtually non-existent, and not located at appropriate locations.

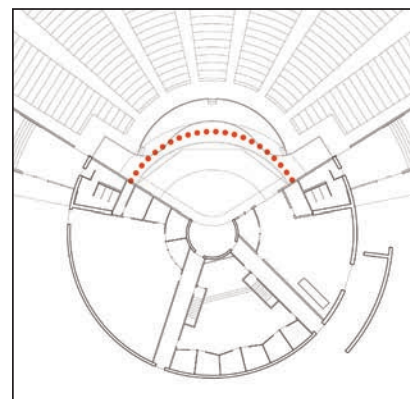
Plan - Overhead House Lighting

1. The audience lighting is very dim, and does not light evenly or attractively. We imagine it is difficult to use for classroom use.
2. The work lighting is very dim, and not the typical 50fc required for a work area
3. The entry station and master controls are not well located.
4. The master stations have been broken, and programming changed, rendering them very difficult to use.

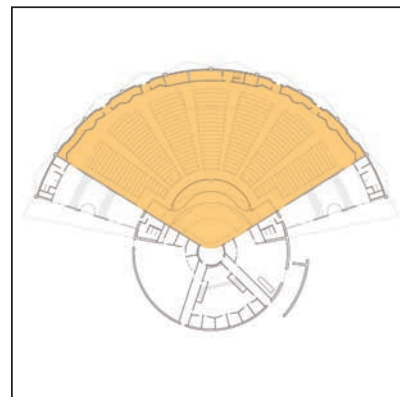
1st Floor Plan - House

The reductions in reverberation time above 125Hz over 25 years is not insignificant as every 0.1sec change is readily noticeable by most people. The 3.2sec figure at 125Hz is problematic and suggests that the reverberation time at lower frequencies today are excessive for future uses. The reason(s) for the changes might be attributed to long-term curing and apparent soot/dust collection of the flocking, as well as changes in the seats. We should learn if and when the seating was changed out or reupholstered as future changes in these will surely materially influence room acoustics.

Clarity of the spoken word in a room seating over 800 normally requires amplification, but just informally listening to unamplified speech on stage from a variety of locations within the audience yielded last week a sense of nearly-sufficient loudness but excessive reverberation to the point of perhaps 50-60% speech intelligibility. A conventionally and well-designed venue of recent design would have yielded far greater clarity in this much reverberance. For example, the recent 1,700-seat Valley Performing Arts Center provides good clarity throughout for unamplified voice, just a drop in desired overall loudness of voice. The reason for the deficiency in clarity at the Frost lies in the absence of good, clear, early sound reflections from anywhere in the room. Nearly all the sound reflections are simply random and diffuse, whereas proper design carefully directs a preponderance of early-reflections from the stage direct to the audience while leaving sufficient later reflections to develop a reverberant "bloom" appropriate to the presentation.

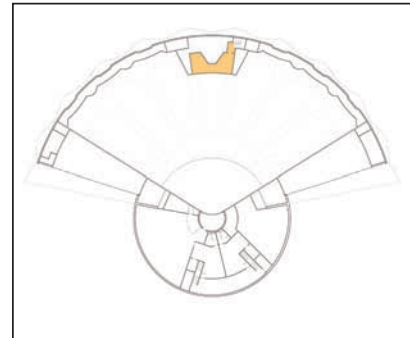
2nd Floor Plan - Control Room

1. The location, window opening size and room finishes provide no ability for a technician to properly assess by direct listening, what a representative large portion of the audience hears.
2. Overall, this is a highly problematic location and outfitting of an audio control room.

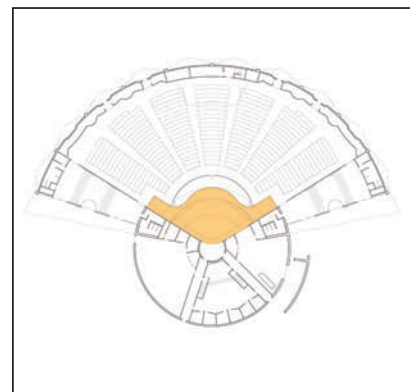
1st Floor Plan - Stage

1. Neither the stage shape or the overhead reflector provide acoustical assistance to either performers or audience.
2. The stage continues the same wide plan form as the house, to no acoustical benefit. Overhead, there is only sound focusing and/or scattering and no returning of sound for benefit.
3. The sunken, partial pit is largely sound-absorptive at high frequencies (carpeted floor and upstage wall [convex face to audience]) providing no means of good balance of pit loudness with on-stage sources for uniform distribution of sound to audience.
4. The design shape, location and configuration of the pit belies good distribution and level control of sound among musicians and to audience.
5. The backstage hallway which is incredibly reverberative, feeds circulation directly to noise generating and noise-sensitive spaces.

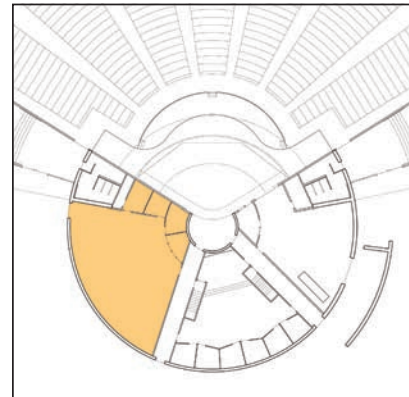
1st Floor Plan - Black Box

It appears the room has been remodeled significantly beyond what the original drawings depict and because we could not measure sound-isolation performance of partitions, it only appears that some isolation assistance to this space is indicated. Doors remain largely ungasketed – or at least without adjustment for full-perimeter, uniform compression of any gaskets. As indicated above, while the room is subject to noise transference to/from the main auditorium's upstage vestibule it is unclear if the adjacent restroom (NW corner) presents an issue.

This is the most immediately-obvious acoustical deficiency of the room in its present condition. Airflow velocities, probably in several areas of the room, exceed good design practice. Of note is the noise and associated air pressure imbalance between a return air shaft to below, that serves the auditorium, and accessible via a door off a side (original) music practice room along the northwest wall. Although HVAC noise here was not measured, we estimate it to be approximately in the range of Noise Criterion (NC) 38-44 – possibly higher in some areas of the room. If this were even made half as loud as this estimate, it would still be nearly twice as loud as good design practice for a Black Box theater.

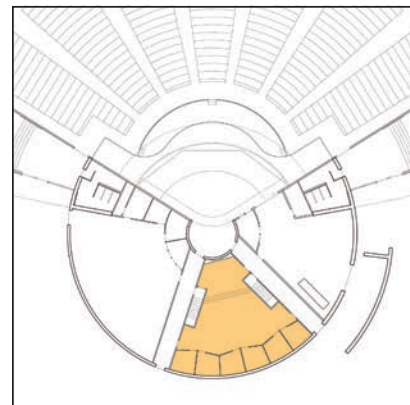
1st Floor Plan - Classroom

1. The location of the classroom underneath the dressing room makes it susceptible to noise transference both from above as well as from the hallway.

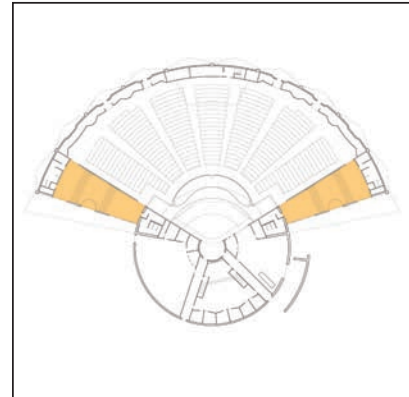
1st Floor Plan - Lobbies

1. The lobbies are incredibly reverberative due to the total lack of sound absorption. This creates a problem with speech intelligibility for people in the lobby and also for ticket sellers as the ticket booths have no ceilings.
2. Reverberating sound in the lobby would get channeled directly into the house even without the doors open due to the lack of gasketing, or vestibules.

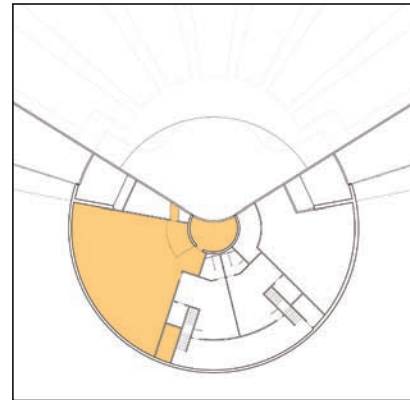
2nd Floor Plan - Mechanical Rm

1. The equipment appears original from the time of construction and is well beyond its service life, therefore should be replaced with higher efficient systems. Table 1 (3.0) describes the zones and the main ducts serving these.
2. This equipment appears to be original and is well beyond its expected service life of 25 years.
3. Outside air ventilation rates need to be increased to meet present day indoor air quality with demand controlled (carbon dioxide sensing) systems installed to conserve energy during low occupancy periods.
4. Presently there is no air conditioning and increasing outside air rates and heat from new electronics will necessitate adding cooling for comfort.
5. The existing systems are constant volume whereas new systems can use variable speed fan motors which save energy costs.

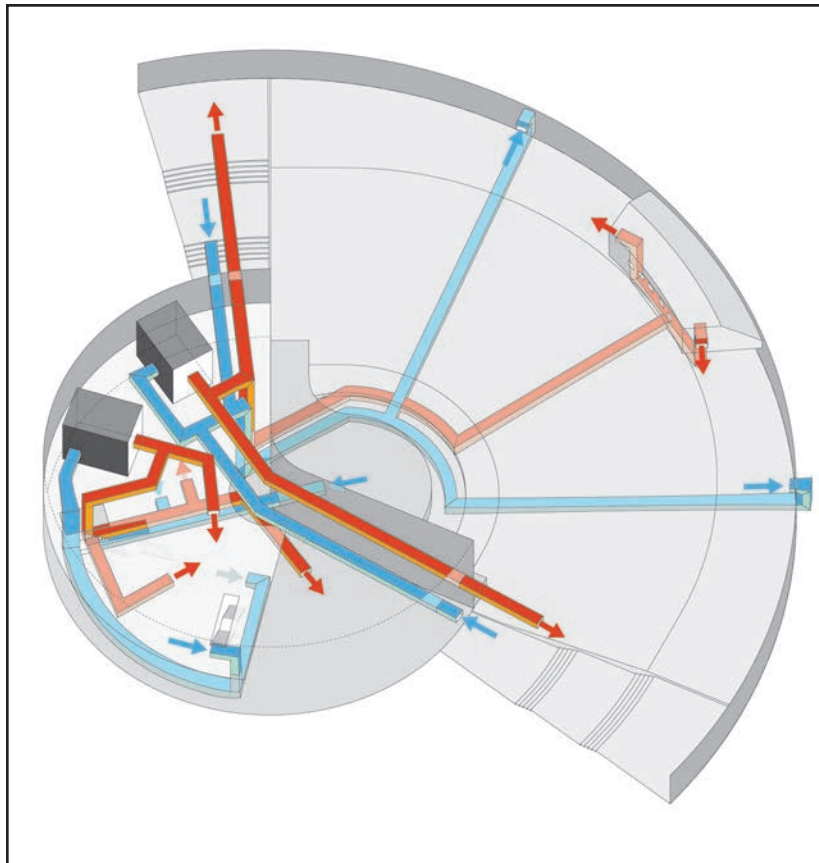
Axon - Air Conditioning System

1. The ductwork we noticed appeared to be in fair condition with duct wrap insulation noted in some areas as deteriorating.
2. The controls are very basic electric, which are considered antiquated and inefficient by today's standards.
3. Filters are standard 30% efficient (MERV 8). Filters with an efficiency of MERV 13 are recommended instead of the standard MERV 8 filters presently used. MERV 13 filters are very good at capturing fine dust and pollens.
4. Outside air indicated on the plans is approximately 25% of the air flows prescribed by present day codes. It is quite common to find systems designed with low outside air flows in older buildings.
5. Some of the ductwork may be re-usable, however further investigation would be required to establish this as a reasonable option.
6. Internal duct cleaning would be recommended, and it is not

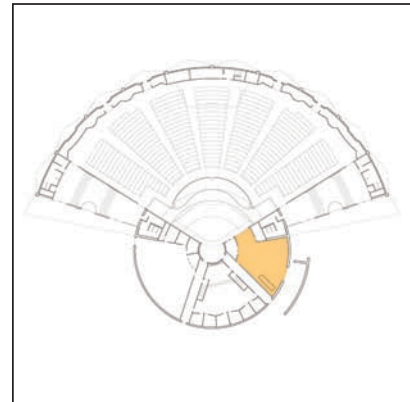
Plan - Areas with Fire Sprinklers

The existing building is equipped with a partial automatic fire sprinkler system and automatic fire alarm system. Sprinklers are provided in all areas except the main theater area, stage, "Black Box" rehearsal room, Classroom #7, ticket booths, public restrooms, main lobbies and projection booth. The fire alarm system does not appear to provide complete notification throughout the public spaces and the coverage of strobes does not meet the ADA requirements. In areas that are not provided with sprinklers it appears that spot-type and beam-type smoke detection is provided. HAI was not provided with information regarding the interconnection of the fire alarm system with the house lighting and sound.

1. The fire alarm system in the Assembly area does not provide emergency voice communication. All Assembly occupancies with an occupant load over 1,000 people are required to have an emergency voice communication system.
2. The fire alarm system appears to not be in compliance with the minimum with coverage for notification of building occupants. Replacement of the existing fire alarm system to comply with the current CBC, ADA and NFPA 72 requirements should be considered.
3. Partial sprinkler protection in the building. Sprinklers required throughout with occupant loads over 300 people in accordance with CBC Chapter 9.
4. Standpipes are not provided on the stage. Recommend installation of standpipe system on the stage in accordance

- with CBC Chapter 9.
5. Obstructions to existing sprinklers and the age of some existing sprinklers are a concern.
 6. Sprinkler system annual and 5-year testing is not up to date. Recommend conducting required testing and maintenance to the sprinkler system.

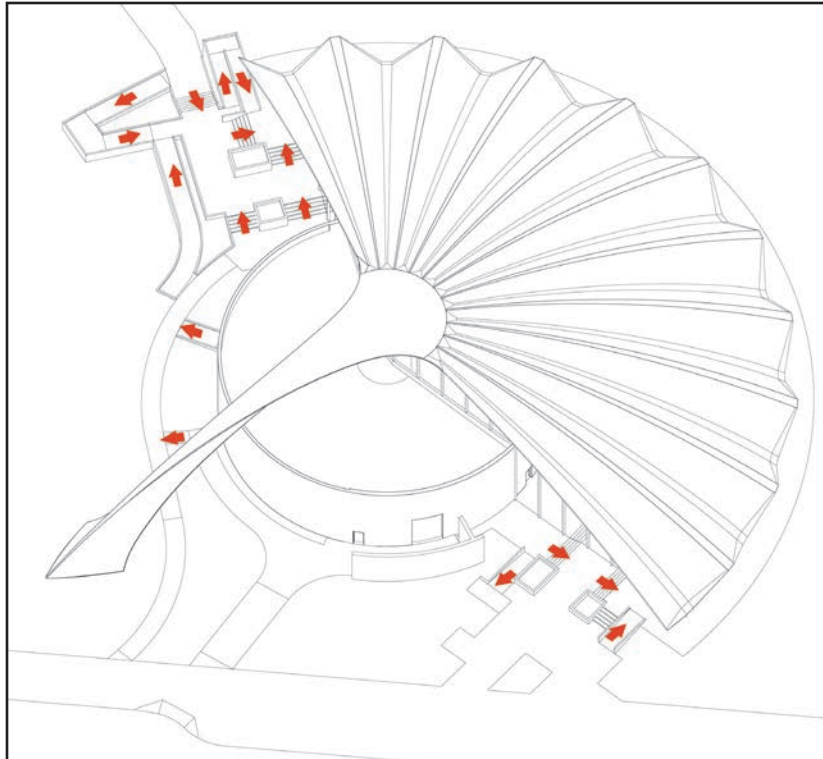
Axon - Ramps and Stairs

The building appears to be primarily original construction pertaining to accessibility and ADA compliance with the exception of the wheelchair ramping at the exterior of the building and some restroom upgrades that appear to have been done in the lobby restrooms. In general the building interior is not compliant with Chapter 11 of the CBC or the ADA guidelines.

1. The seating in the theater does not provide adequate wheelchair seating. Recommend revising the seating arrangement to provide adequate wheelchair seating including companion seating and designated aisle seating in select locations.
2. It did not appear that assistive listening devices were provided in the theater seating area. Recommend providing permanently installed assistive listening devices in the theater seating area.
3. The access to the men's public restrooms is only provided from the rear of the lobbies and the women's public restrooms are only provided at the lower level of the lobbies. Recommend reconfiguring the restrooms to allow for access to both men and women at both elevations.

4. There is no wheelchair access to the orchestra area. Recommend providing ramping to accommodate wheelchair access to the orchestra area.
5. There is no wheelchair access to the second floor dressing rooms. Recommend either providing access to the second floor dressing rooms or provide equivalent accommodations on the accessible level of the building.

7. The platform in Room# 7 is not wheelchair accessible.
8. The slope of the aisles in the Theater is very steep and appears to not satisfy the maximum slope allowed. Recommend reconfiguring the slope of the aisle or provide alternate access at the center elevation for wheelchair access.

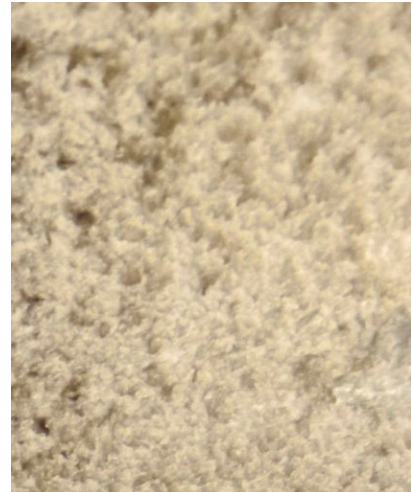
78

1. The International Cellulose Corporation advertises the K-13 system with the ability to garner LEED points for Recycled Content and Low-Emitting Materials.
2. The contractor in 1984 had concerns that the top of the canopy should be encapsulated. It was to be vacuumed during the asbestos removal but there was concern that it would not be completely removed due to the rough surface and could become airborne at a later date.

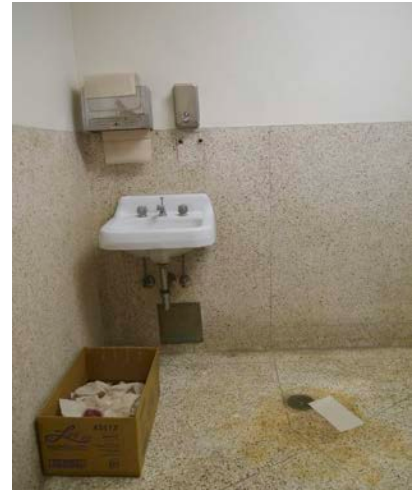
106

Lighting access
Lack of effective projection system
Front lighting is terrible
Fire sensors are an issue with lighting positions
Preset panel is half broken
Better speaker system needed
Many lights broken/outdated
Radial lighting grid is a problem

No light locks
Doors open to show restroom access
Bathroom noise in house
Terrible acoustics
Entry and exit with full house really doesn't work
Impossible to project into space without a microphone
Seating layout doesn't work.
