## NEEDS ASSESSMENT SUMMARY

### I. CCUSD OVERVIEW

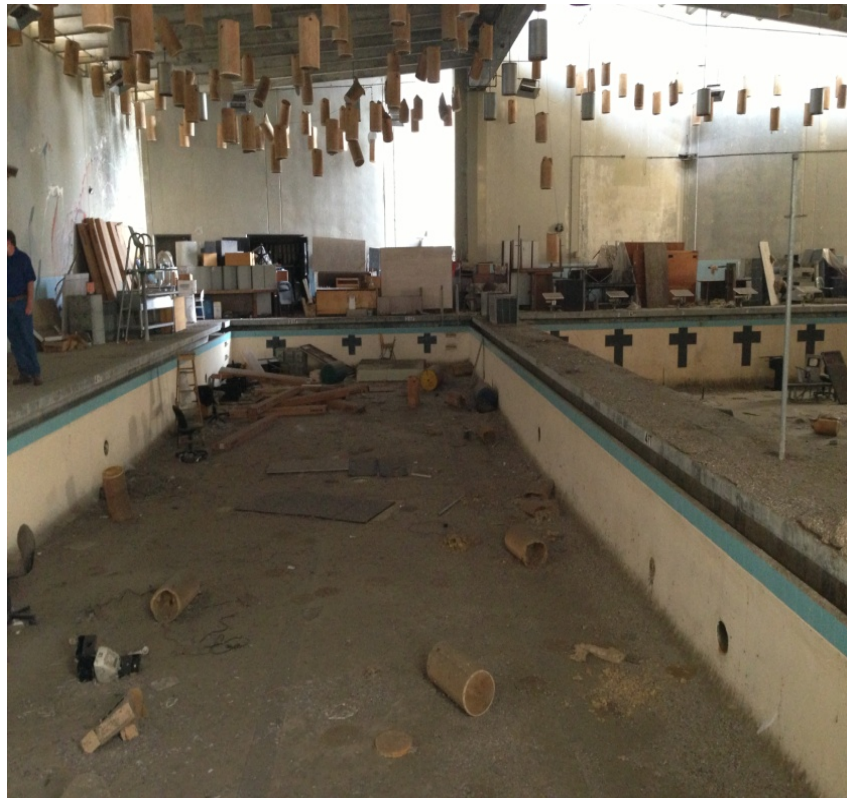
standards. Below is a copy of the former aquatics facility known as the Natatorium, which has shut down and has been closed for over two decades, which is a clear representation of Culver City's need to modernize its facilities.
